white RIVER PLAN

Task Three: Hydrology, Water Quality & Ecology

**TASK THREE: HYDROLOGY, WATER QUALITY
& ECOLOGY**

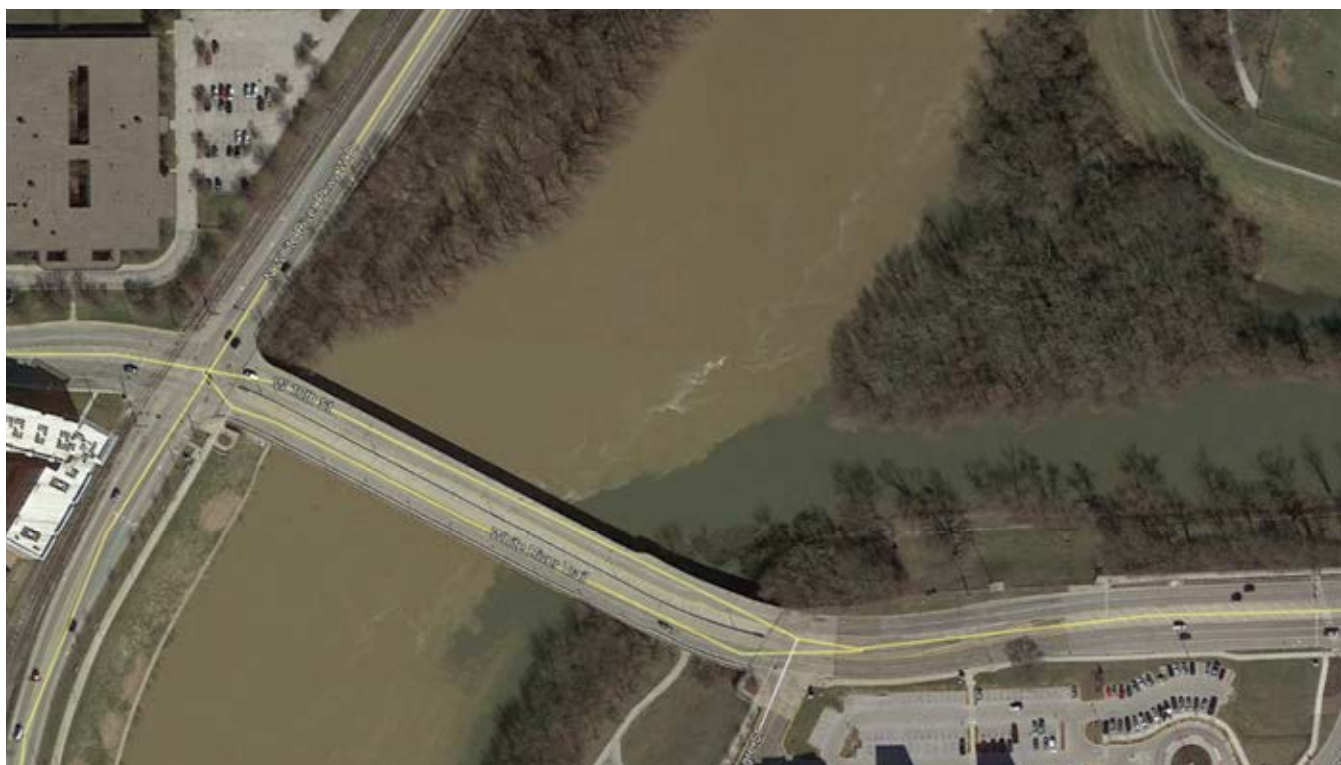
CONFLUENCE OF FALL CREEK AND SEDIMENT-LADEN WHITE RIVER. (SOURCE: GOOGLE MAPS, 2018)

Reducing sediment inputs to the river would improve the river in many ways. Stream banks and beds erode from too much water, and sediment loads increase, burying fish spawning grounds and mussel beds. Mercury and PCBs (polychlorinated biphenyls) are chemically bound in river sediment, which has led to a fish consumption advisory. A lot of the phosphorus is bound to particles of sediment. If phosphorus-laden sediment is prevented from reaching the river, this would stop most of the algal blooms in the White River.

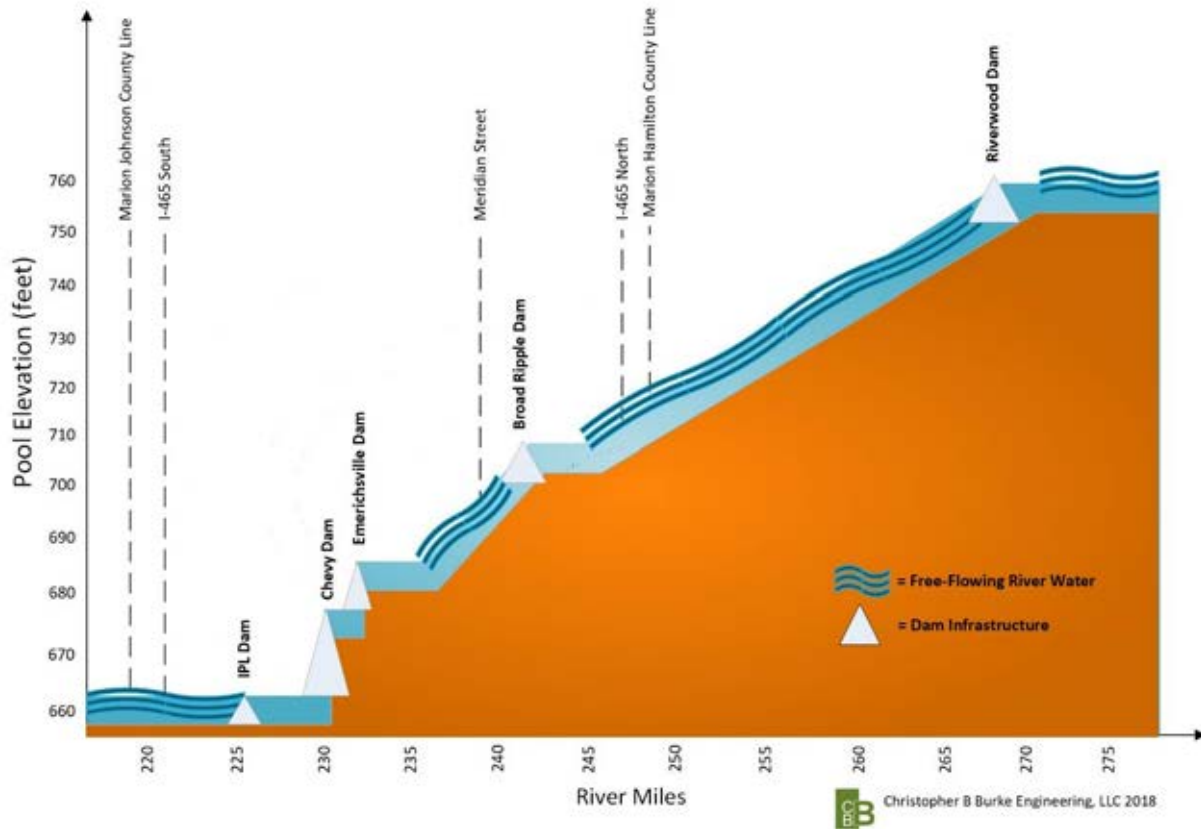
White River Low-Head Dam Pool Impact Areas

Estimated from FIS Profiles and Topographic Data

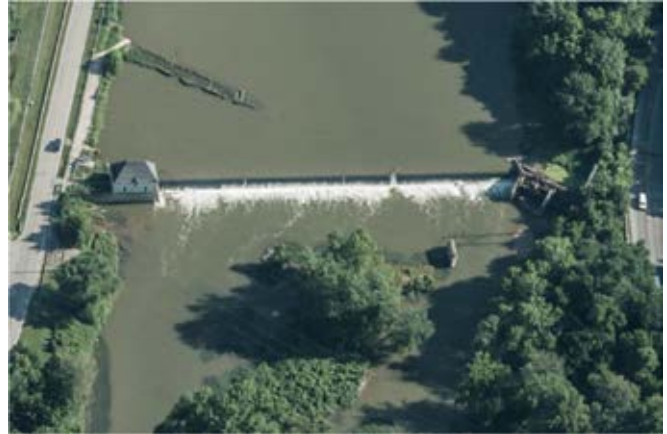
Riverwood Power Dam

Conditionally poor (1/18/18 inspection); recommendations – clear debris from structure, tainter gates, and out of roller area

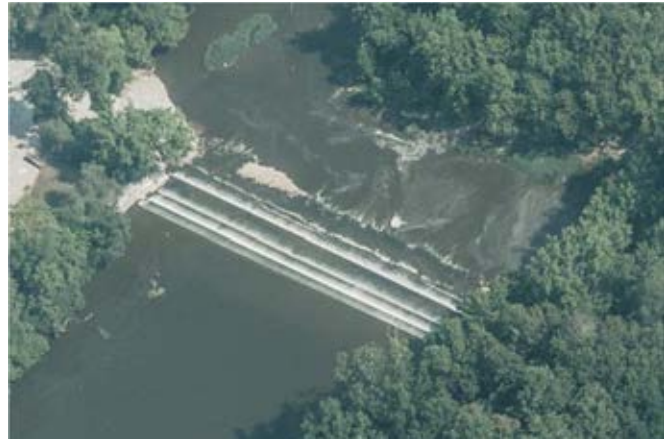
SOURCE: GOOGLE MAPS, 2018

The Dam is a segment of the Central Canal that was significant in the development of Indianapolis. Its construction drew in

laborers causing a population increase and new industries emerged along its path. Based on 11/7/1925 profile cross-section page in its inspection file, the dam appears to be 300 feet across. The dam was worked on in 1921-1922, 1924, 1925, and more recently between the 3-20-2012 and 2-14-2017 inspections. The dam looks totally different and no plans or permits are on file in the Dam and Levee Safety Section.

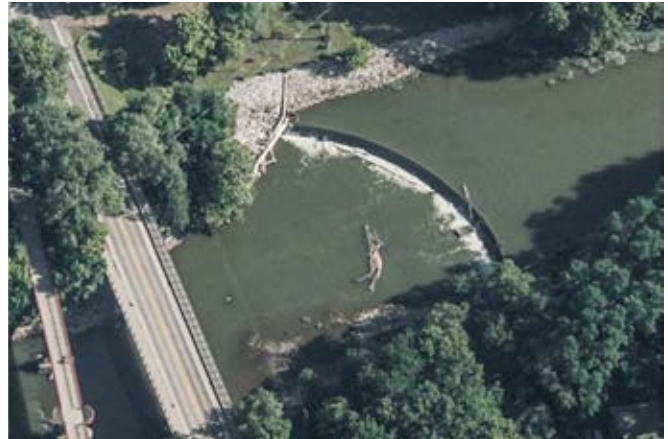
SOURCE: GOOGLE MAPS, 2018

Structure was built for stabilization purposes, to stabilize the grade in Williams Creek and to maintain the White River Elevation for the

Broad Ripple Dam and the canal.

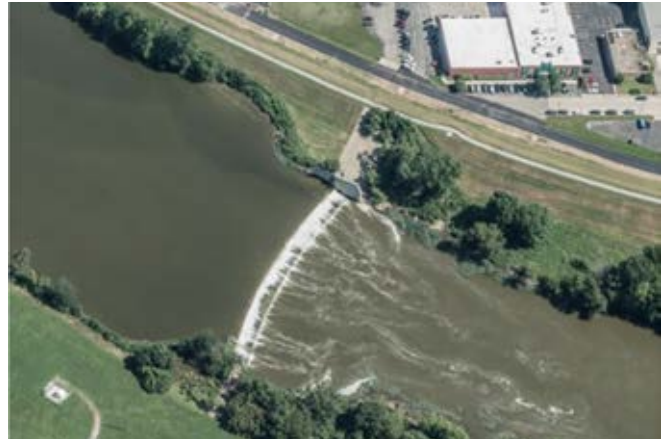
SOURCE: GOOGLE MAPS, 2018. NOTE: DAM FAILED SEPT 2018 AND HAS SINCE BEEN STABILIZED. THE CITY WILL NEED TO DECIDE HOW TO MOVE FORWARD WITH RESTORATION/RETROFIT. (PHOTO NOV 2018)

Seriously deficient (12/5/17 inspection). Recommendations: Emerichsville Dam failed in September 2018 and has since been stabilized. At this time the city has yet to decide the long-term use and function of this structure. CEG is in the process of determining the location and design of a

replacement dam upstream to support their water intake. Recommendations include to construct structural modifications to the dam to significantly reduce or eliminate the opportunity for a submerged hydraulic jump to form. Install signage and buoys to improve the safety at the dam. Coordinate with DNR Law Enforcement regarding potential designation of a safe portage around the dam.

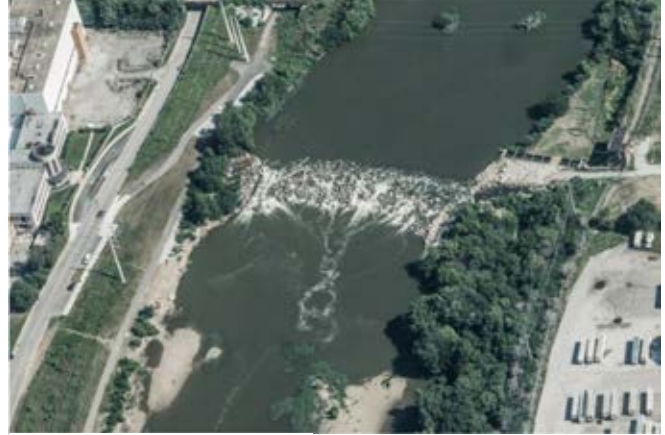
SOURCE: GOOGLE MAPS, 2018.

Fair condition (1/21/18 inspection); recommendations – clear debris out of roller area, remove local camper near dam shore

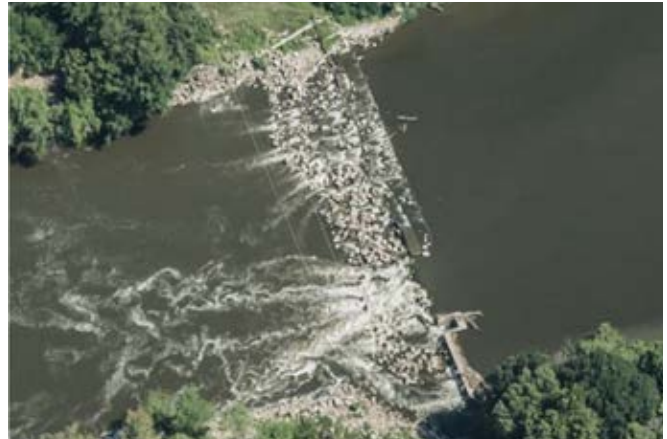
SOURCE: IDNR [HTTPS://WWW.IN.GOV/DNR/OUTDOOR/9419.HTM](https://www.in.gov/dnr/outdoor/9419.htm)

Built as a wood crib dam originally for a grist mill in the 1920s. Rock and sheet piling have since been added. Dam received repairs in 1938.

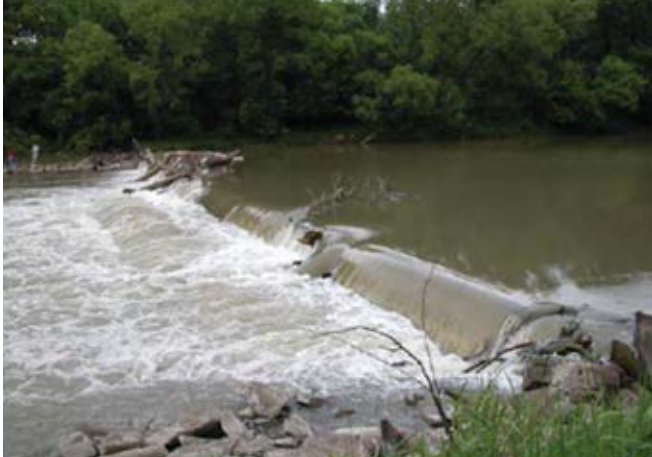
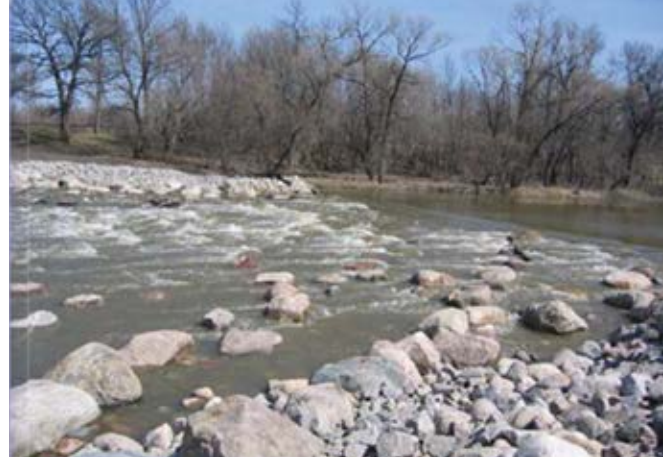
BEFORE / SOURCE: MN DNR

AFTER / SOURCE: MN DNR

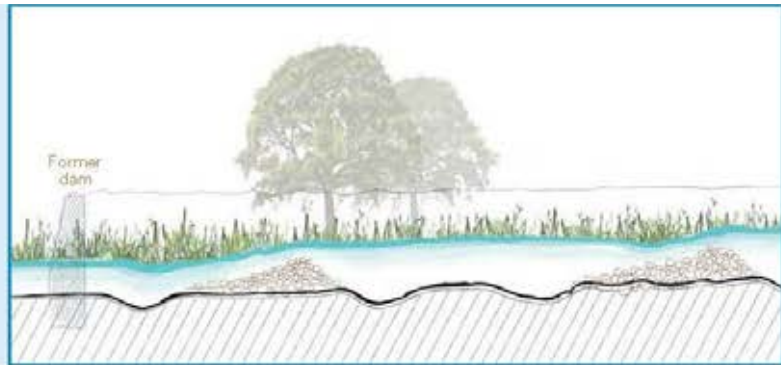
Complete dam removal with river restoration

Maintenance costs for aging and deteriorating dams can be eliminated through complete dam removal. Floodplains restored with native vegetation in the former impoundment stabilize banks and improve water quality. Rock riffles help stabilize channel beds.

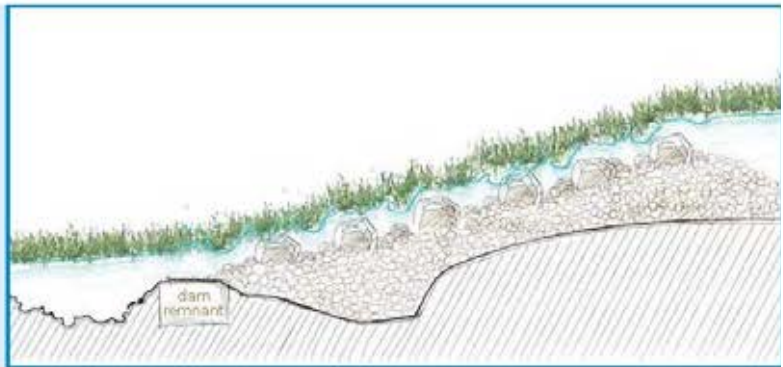
Rock arch rapids

Some deteriorating and dangerous dams that still serve a purpose, such as maintaining depth for water supply, can be replaced with a backsloped rock arch rapids. The rock ramp maintains the water height of the former dam but improves safety and allows fish passage.

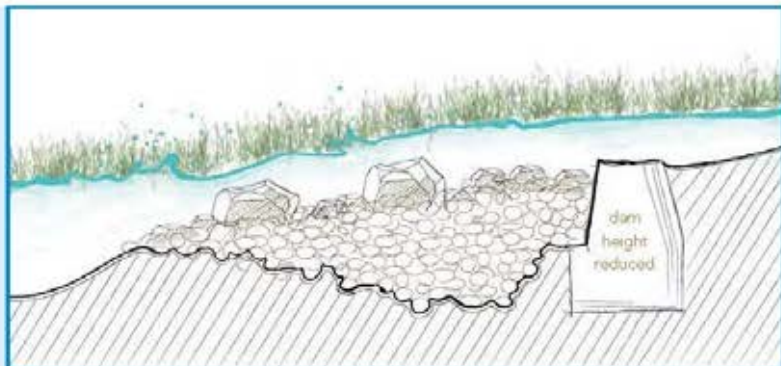
Height reduction

Partial removal of a dam is preferred when complete removal would cause the excessive release of sediment. The rock ramp eliminates the dangerous recirculating current, allows fish passage, and transports sediment more slowly downstream.

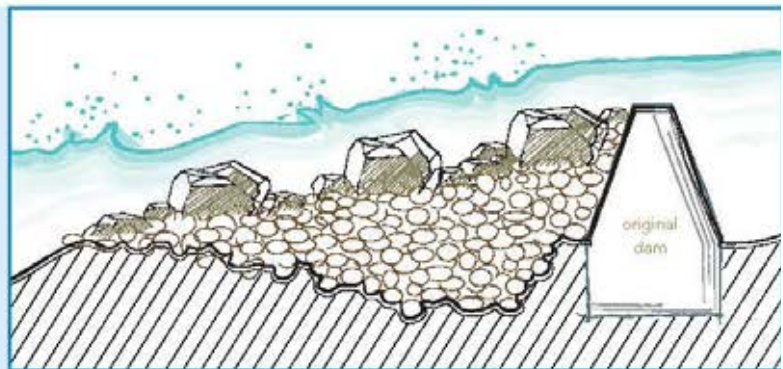
Rock ramps

Dangerous recirculating currents can be eliminated without removing a dam by strategically placing rocks and boulders downstream of the dam. The sloped rock formations also allow fish to reconnect with the river upstream.

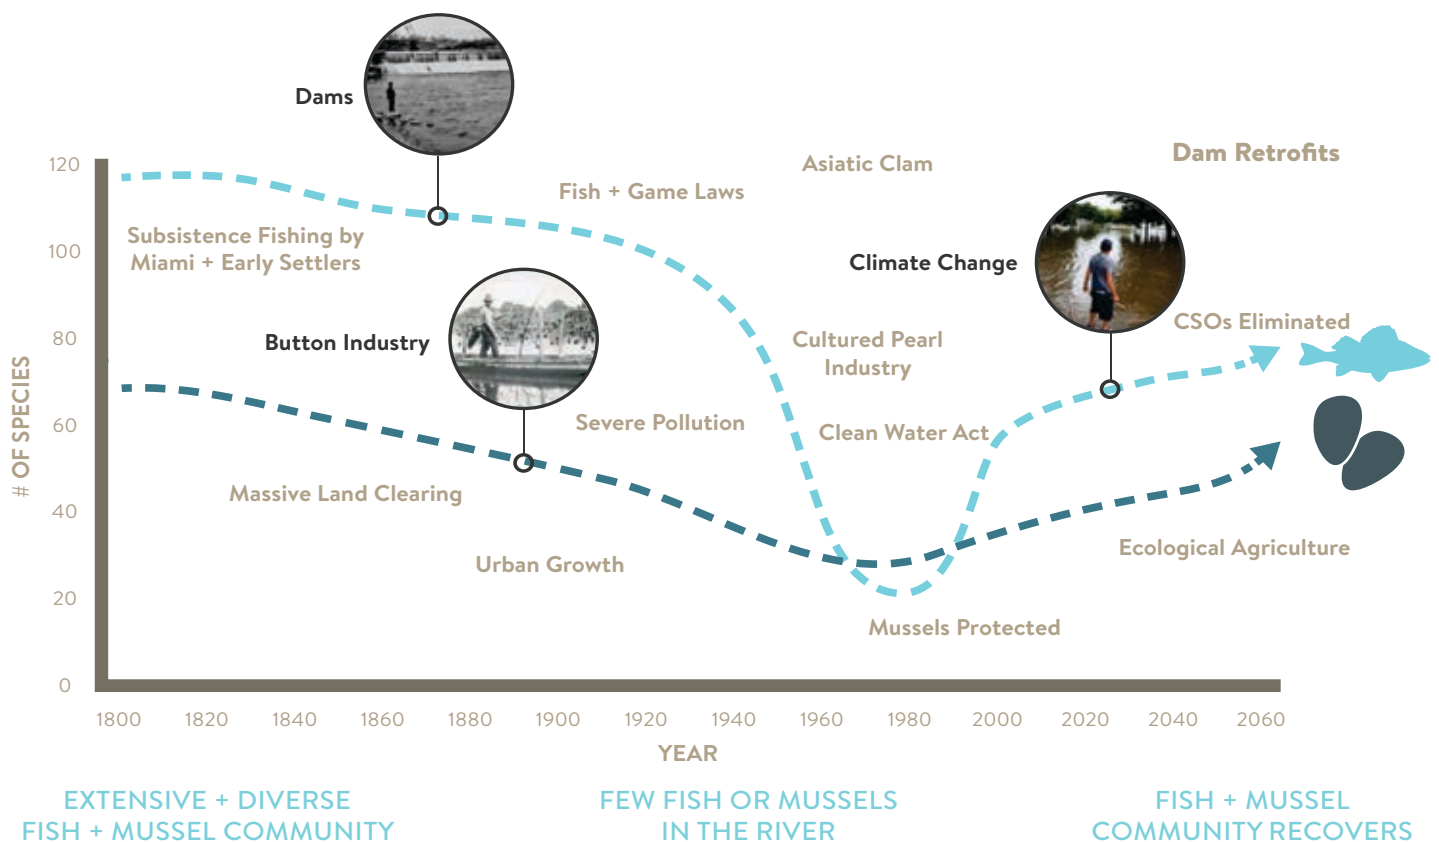
RISE AND FALL OF THE FISH AND MUSSEL POPULATION.

Water pollution, dams, and over-harvesting have all devastated fish and mussel populations in the White River. As water clean-up, dam retrofits, reintroductions, and limits or bans on harvesting continue, ongoing inventory and monitoring of the response of fish and mussel populations is critical in tracking the success of these efforts.

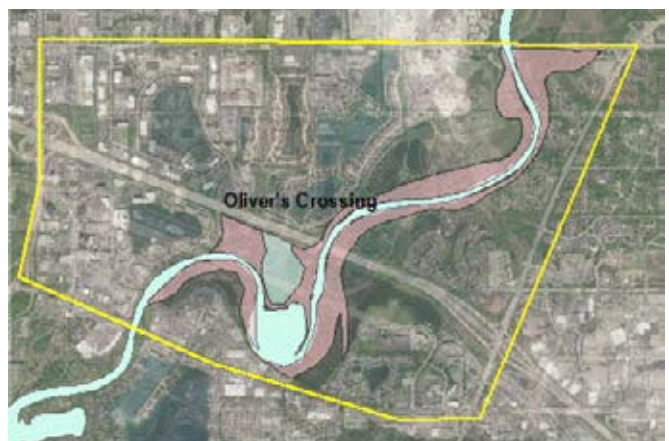
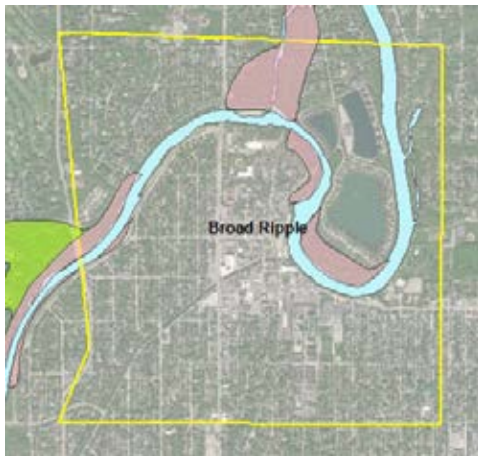
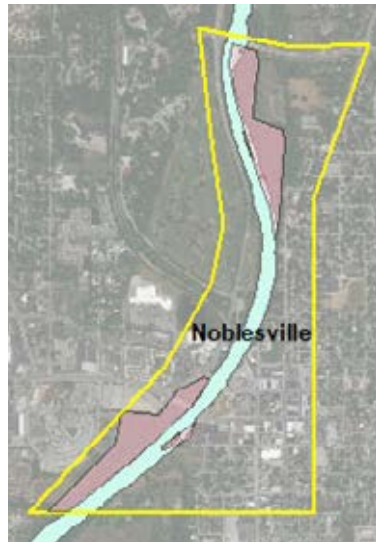
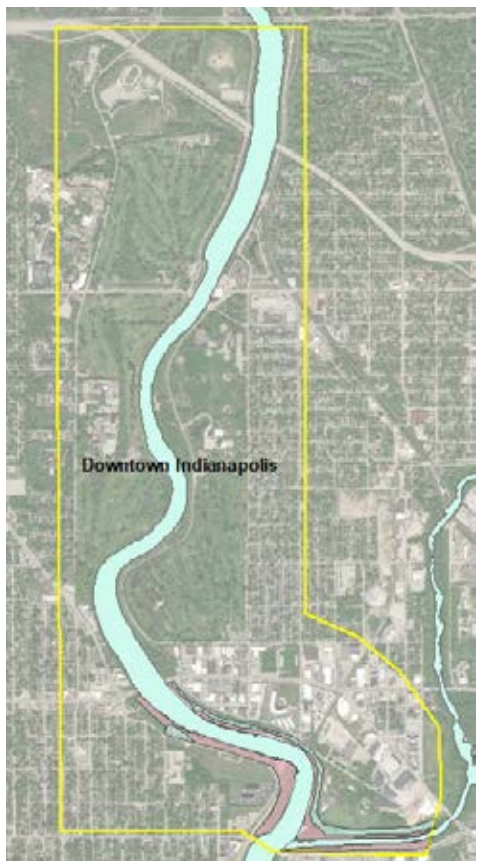
These diagrams illustrate the restoration and enhancement strategies within the White River Master Plan's seven focus areas.

Restoration efforts in these seven focus areas provide ecological benefit to many identified "Important Natural Areas," as well as providing public recreational and aesthetic value. They also serve as a model for future restoration and enhancement efforts in other reaches of the White River. Over time, if practiced in with this recommended methodology, the White River will consist of a connected, diverse biological corridor in an urban and rural landscape.
